MISSISSIPPI RIVER: STUDY OF ALTERNATIVES FOR
REHABILITATION OF LOCK AND D..(U) CORPS OF ENGINEERS ST
PAUL MN ST PAUL DISTRICT APR 76

MISSISSIPPI RIVER

GEOLOGY, FOUNDATIONS AND SOILS INVESTIGATIONS

GEOLOGY AND FOUNDATION EXPLORATION

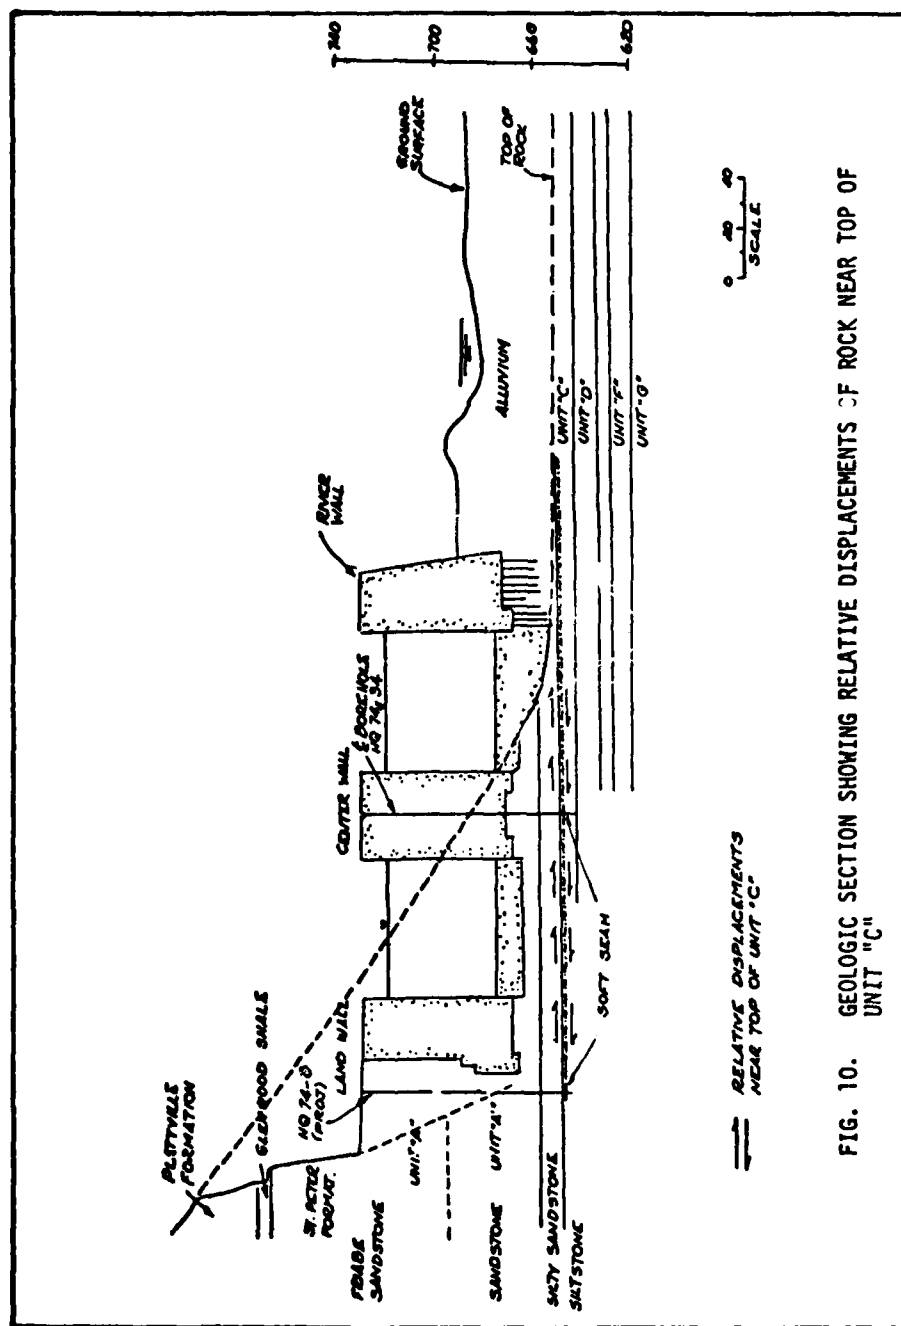
FIG. 10. GEOLOGIC SECTION SHOWING RELATIVE DISPLACEMENTS OF ROCK NEAR TOP OF UNIT "C"

three geologic cross sections furnished by Mr. B. I. Maduke. One of those cross sections is reproduced here as Fig. 10.

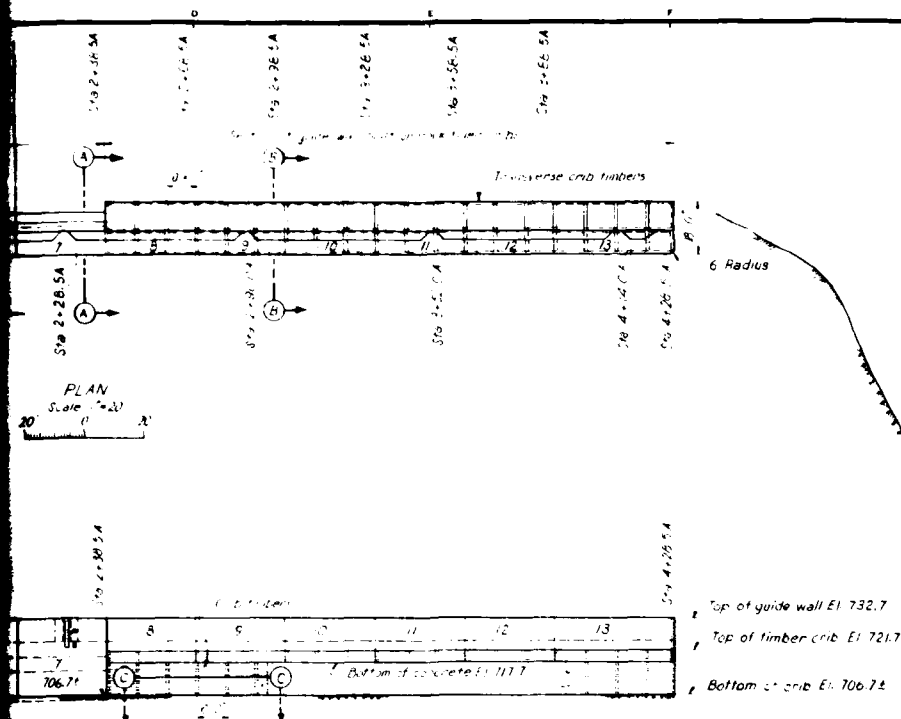
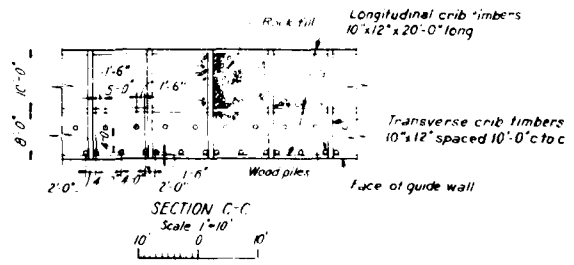
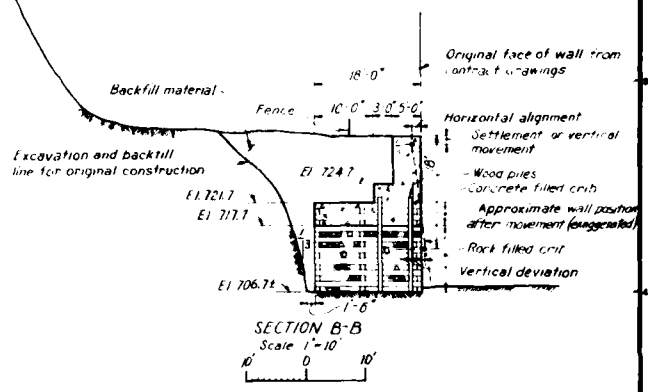
TABULATION OF WALL MOVEMENTS
See sections A-A & B-B

Station	1934-1963 Recorded max horizontal movement	1936-1963 Recorded max vertical movement	1950-1963 Recorded max vertical deviation
4+23.6A	0.14 West	0.02 upward	0.45 East
1+89.0A	0.12 West	0.02 upward	0.18 East
0+71.0A	0.12 West	0.02 upward	0.09 East

1. Elevations refer to Mean Sea Level Datum.
2. Spalling problem at most monolith and horizontal joints which are void of joint material (1971 inspection report).
3. Cracks in center of monoliths 8 to 13.
4. Elevations of structure shown are those taken from original contract drawings (before movements) except noted.

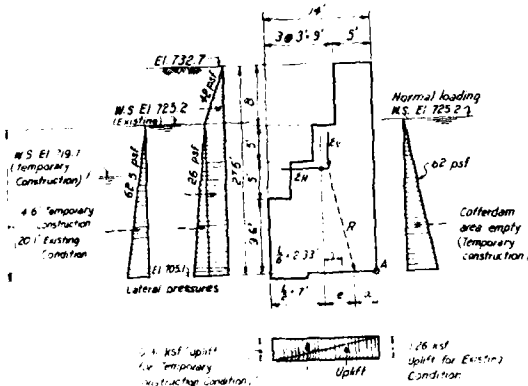
UPPER GUIDE WALL MONOLITHS 1-7 EXISTING AND CONSTRUCTION CONDITIONS

Monoliths 1-7 Existing, Normal Loading condition	Monoliths 1-5 Temporary construction Loading condition
(1) Resultant	3.72 ft -1.39 ft	4.42 ft -1.89 ft
(2) Soil	7.46 ksf	11.34 ksf
(3) E_H/E_V	3.5	4.4
(4) F.S.S.	1.80	1.4
(5) F.S.O.T.	1.48	1.57

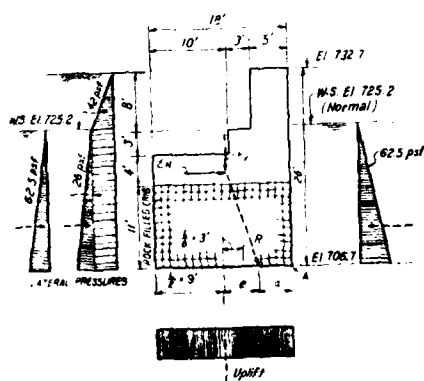
UPPER GUIDE WALL MONOLITHS 8-13 EXISTING, NORMAL LOADING CONDITION

(1) Resultant	3.40 ft -0.60 ft
(2) Soil	4.12 ksf
(3) E_H/E_V	11
(4) F.S.S.	1.90
(5) F.S.O.T.	2.06

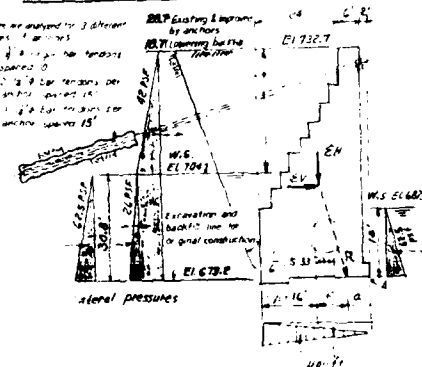
LAND WALL MONOLITHS 5-15 - Existing, Temporary construction and improved, Normal Loading Conditions

Existing Normal Loading	Temporary Construction Loading	Improved stability by 10' Lowering of Backfill, Normal loading
(1) Resultant	8.56 ft -3.23 ft	8.50 ft -3.20 ft	6.59 ft -2.26 ft
(2) Soil (max)	17.74 ksf	18.84 ksf	12.33 ksf
(3) E_H/E_V	43	46	36
(4) F.S.S.	1.44	1.35	1.74
(5) F.S.O.T.	1.57	1.50	1.87

Notes are analyzed for 3 different
cases: 1. Existing
2. 2-1/2" bar tendons
spaced 10'
3. 2-1/2" bar tendons
spaced 15'

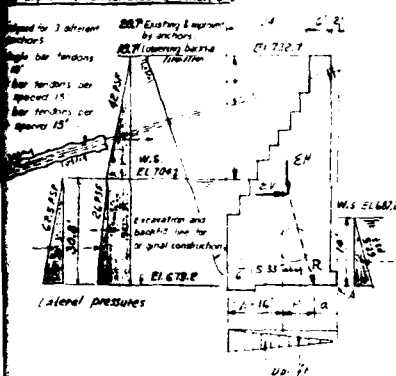
LAND WALL MONOLITHS 3 IS - Existing Temporary Construction
Improved Normal Loading Conditions

Existing Normal Loading	Temporary Construction Loading	Improved Stability by 10' Lowering of Backfill, Normal Loading
Resultant E	8.56 ft	8.30 ft	6.59 ft
1) f_{soil}	17.74 ksf	18.04 ksf	12.33 ksf
2) EH/EV	1.44	1.35	1.74
3) F.S.	1.57	1.50	1.87

1 1/2" single bar tendons spaced 10'	2 1/2" bar tendons/anchor spaced 15'	3 1/2" bar tendons/anchor spaced 15'
Resultant E	4.86 ft	4.97 ft	2.50 ft
1) f_{soil}	12.0 ksf	12.0 ksf	12.0 ksf
2) EH/EV	1.35	1.35	1.35
3) F.S.	1.76	1.76	1.76
4) F.S.O.T.	2.37	2.37	2.37

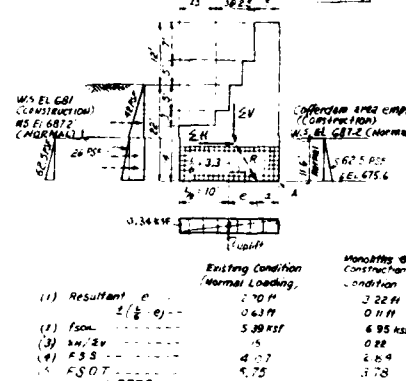
LOWER GUIDE WALL MONOLITHS 3 IS - EXISTING AND IMPROVED NORMAL LOADING CONDITIONS

Existing Condition Normal Loading	Monoliths 3 IS Construction Loading
1) Resultant E	2.70 ft	3.24 ft
2) f_{soil}	5.39 ksf	6.95 ksf
3) EH/EV	1.5	0.88
4) F.S.	4.07	2.69
5) F.S.O.T.	5.75	3.78

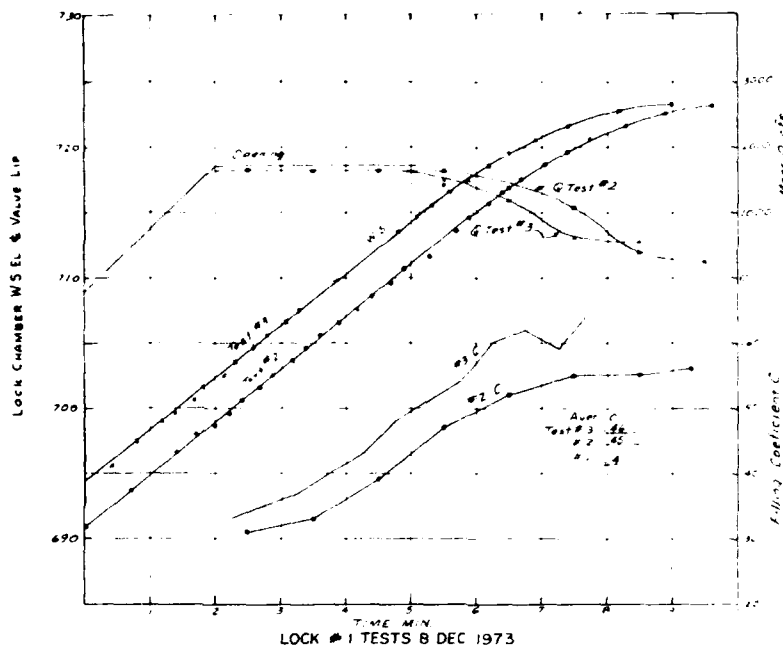
The results of these computations are shown in Figure 1 (see Drawing 5/39). The slope of the filling curve is precisely the same in both tests and the rate of filling is identical until the water level in the lock chamber reaches approximately elevation 713.6. This indicates that the flow in this part of the filling operation is controlled solely by the culvert system upstream from the drop section. As the increasing back pressure suppresses the jump, the curve assumes the characteristic shape of usual filling curves.

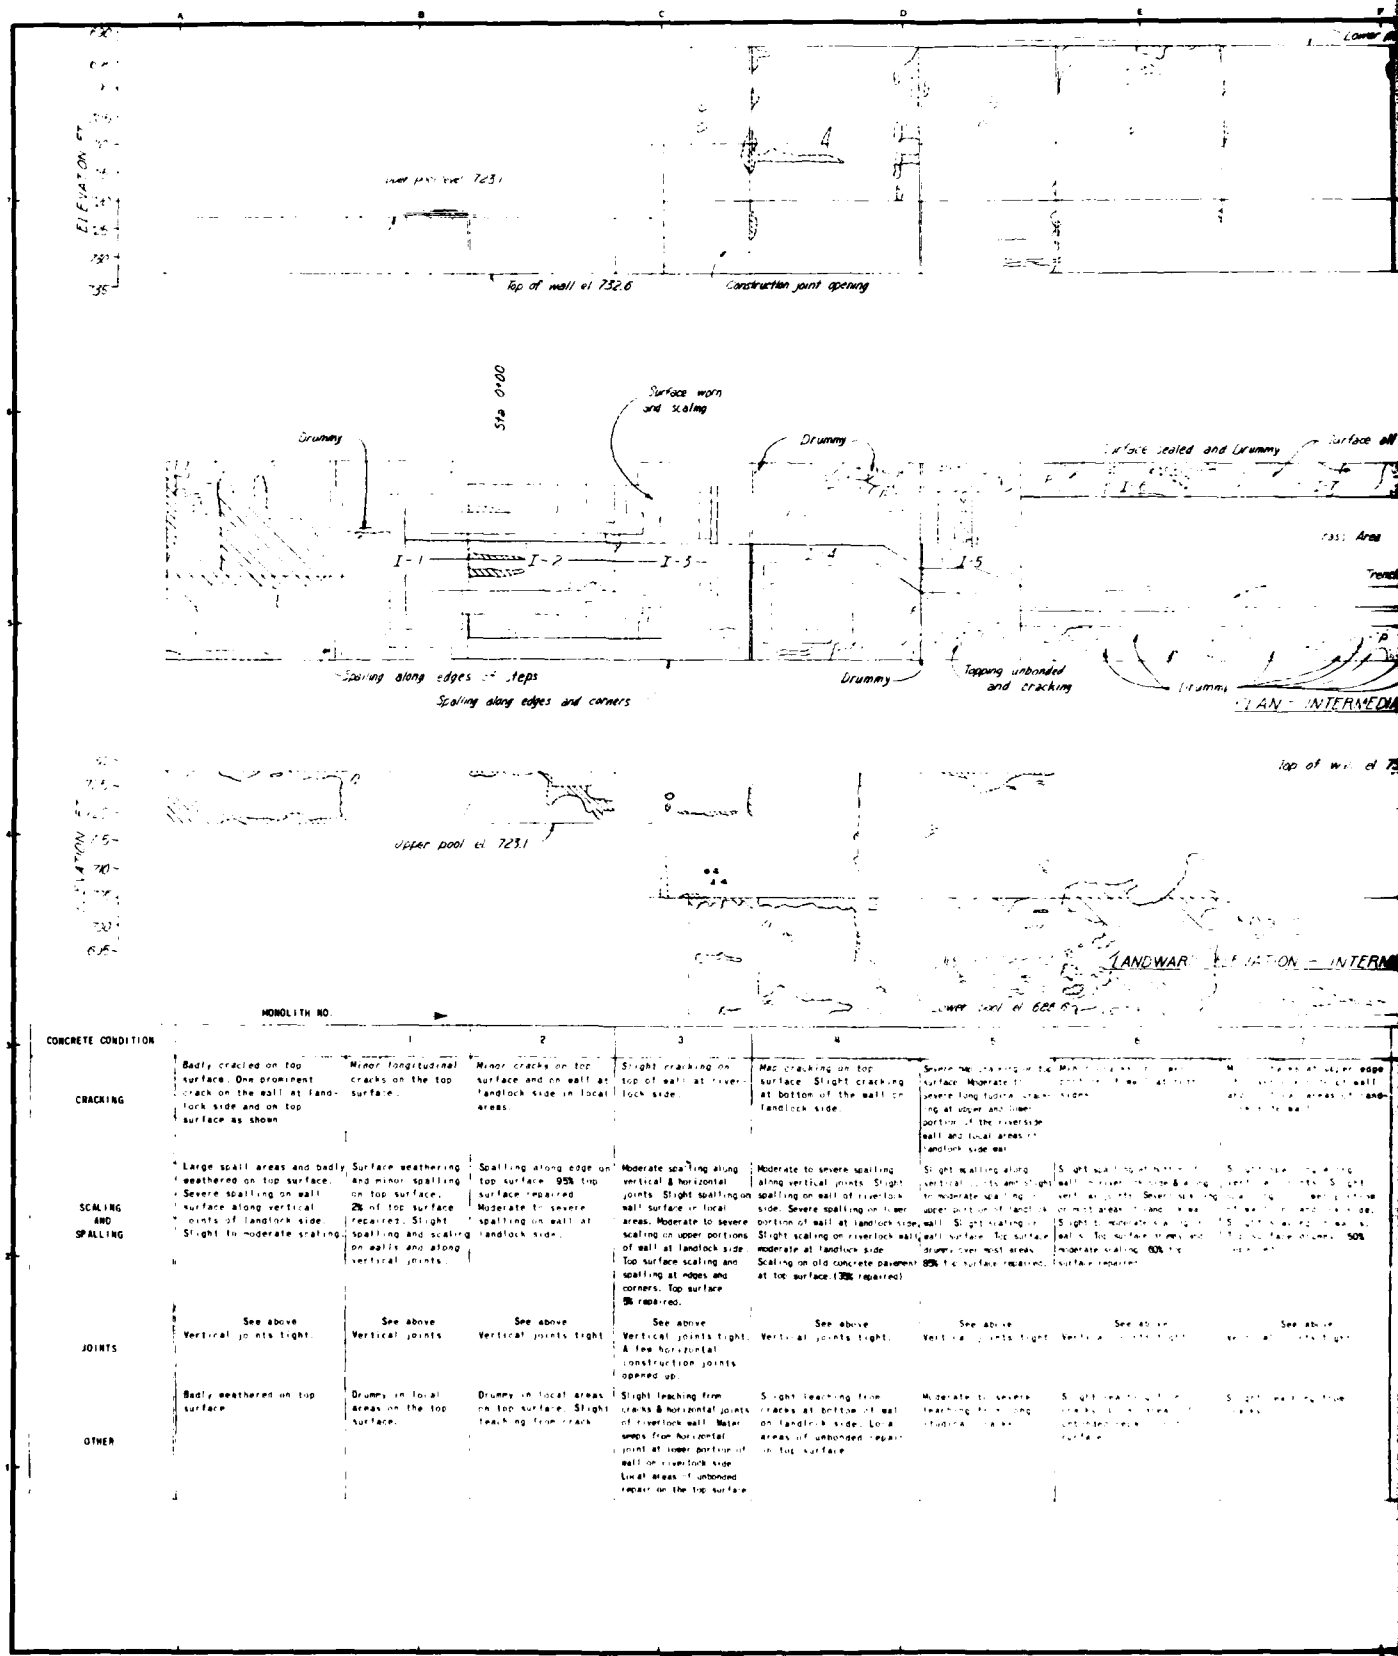
<p>Severe cracking on top surface. Moderate to severe longitudinal cracking at water and lower portion of the river side and local areas of wall side wall.</p> <p>Slight spalling along vertical joints and slight to moderate spalling on lower portion of landlock wall. Slight scaling on all surface. Top surface heavy over most areas. 50% top surface repaired.</p> <p>See above Vertical joints tight.</p>	<p>Minor cracks on lower portion of wall at both sides.</p> <p>Slight spalling at bottom of wall on river side & along vertical joints. Severe spalling on most areas of landlock wall. Slight to moderate scaling on walls. Top surface drummy and moderate scaling. 60% top surface repaired.</p> <p>See above Vertical joints tight.</p>	<p>Minor cracks at upper edge of river side of wall and in local areas of landlock side wall.</p> <p>Slight spalling along vertical joints. Slight spalling on lower portion of wall on landlock side. Slight scaling on walls. Top surface drummy. 50% repaired.</p> <p>See above Vertical joints tight.</p>	<p>Drumming on top of wall. Minor cracks at lower portion of wall on landlock side.</p> <p>Slight wall up at the lower landlock side wall. Moderate to severe spalling on portions of walls above waterline. Slight scaling on walls. Top surface heavy over most areas. 50% top surface repaired. 50% top surface repaired.</p> <p>See above Vertical joints tight.</p>

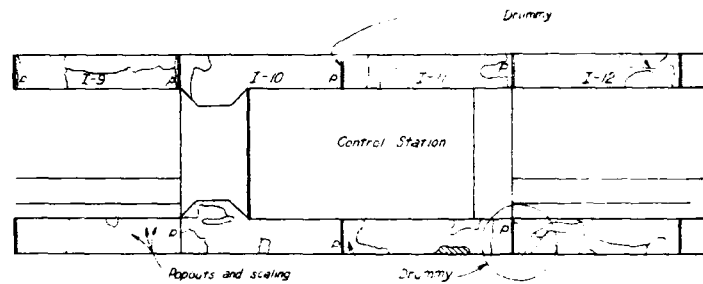
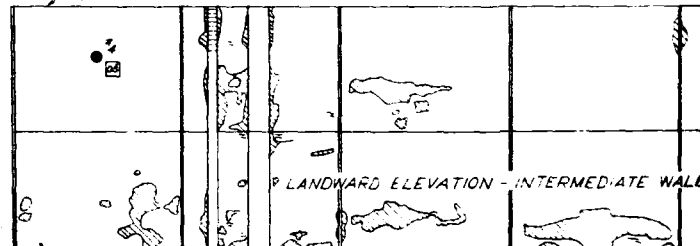
PLAN - INTERMEDIATE WALL

(CONTINUED)		MONOLITH NO.			
CONCRETE CONDITION		9	10	11	12
CRACKING		Mainline cracks on top surface. Minor cracks at lower portion of wall on landlock side.	Cracks, scaling, and cracking along recessed top surface. Minor cracks in local areas on wall at landlock side.	Diagonal cracking at upper portion of wall. Cracks in upper portion of wall. Minor cracking in local areas on wall at landlock side.	Mainline cracks on top surface. Minor cracks at lower portion of wall on landlock side.
SCALING AND SPALLING		Slight spalling along vertical joints. Slight to moderate spalling on lower portion of walls. Slight to moderate scaling on walls. Top surface weathered. 20% repaired.	0% concrete pavement on the surface weathered. Moderate spalling along vertical joints. Slight spalling on walls in local areas. Slight to moderate scaling on both walls. 10% top surface repaired.	Moderate scaling on top surface. Slight spalling along vertical joints and on walls in local areas. Moderate to severe scaling on walls. Slight to moderate scaling on both walls. 10% top surface repaired.	Moderate scaling on top surface. Slight spalling along vertical joints and on walls in local areas. Moderate to severe scaling on walls. Slight to moderate scaling on both walls. 10% top surface repaired.

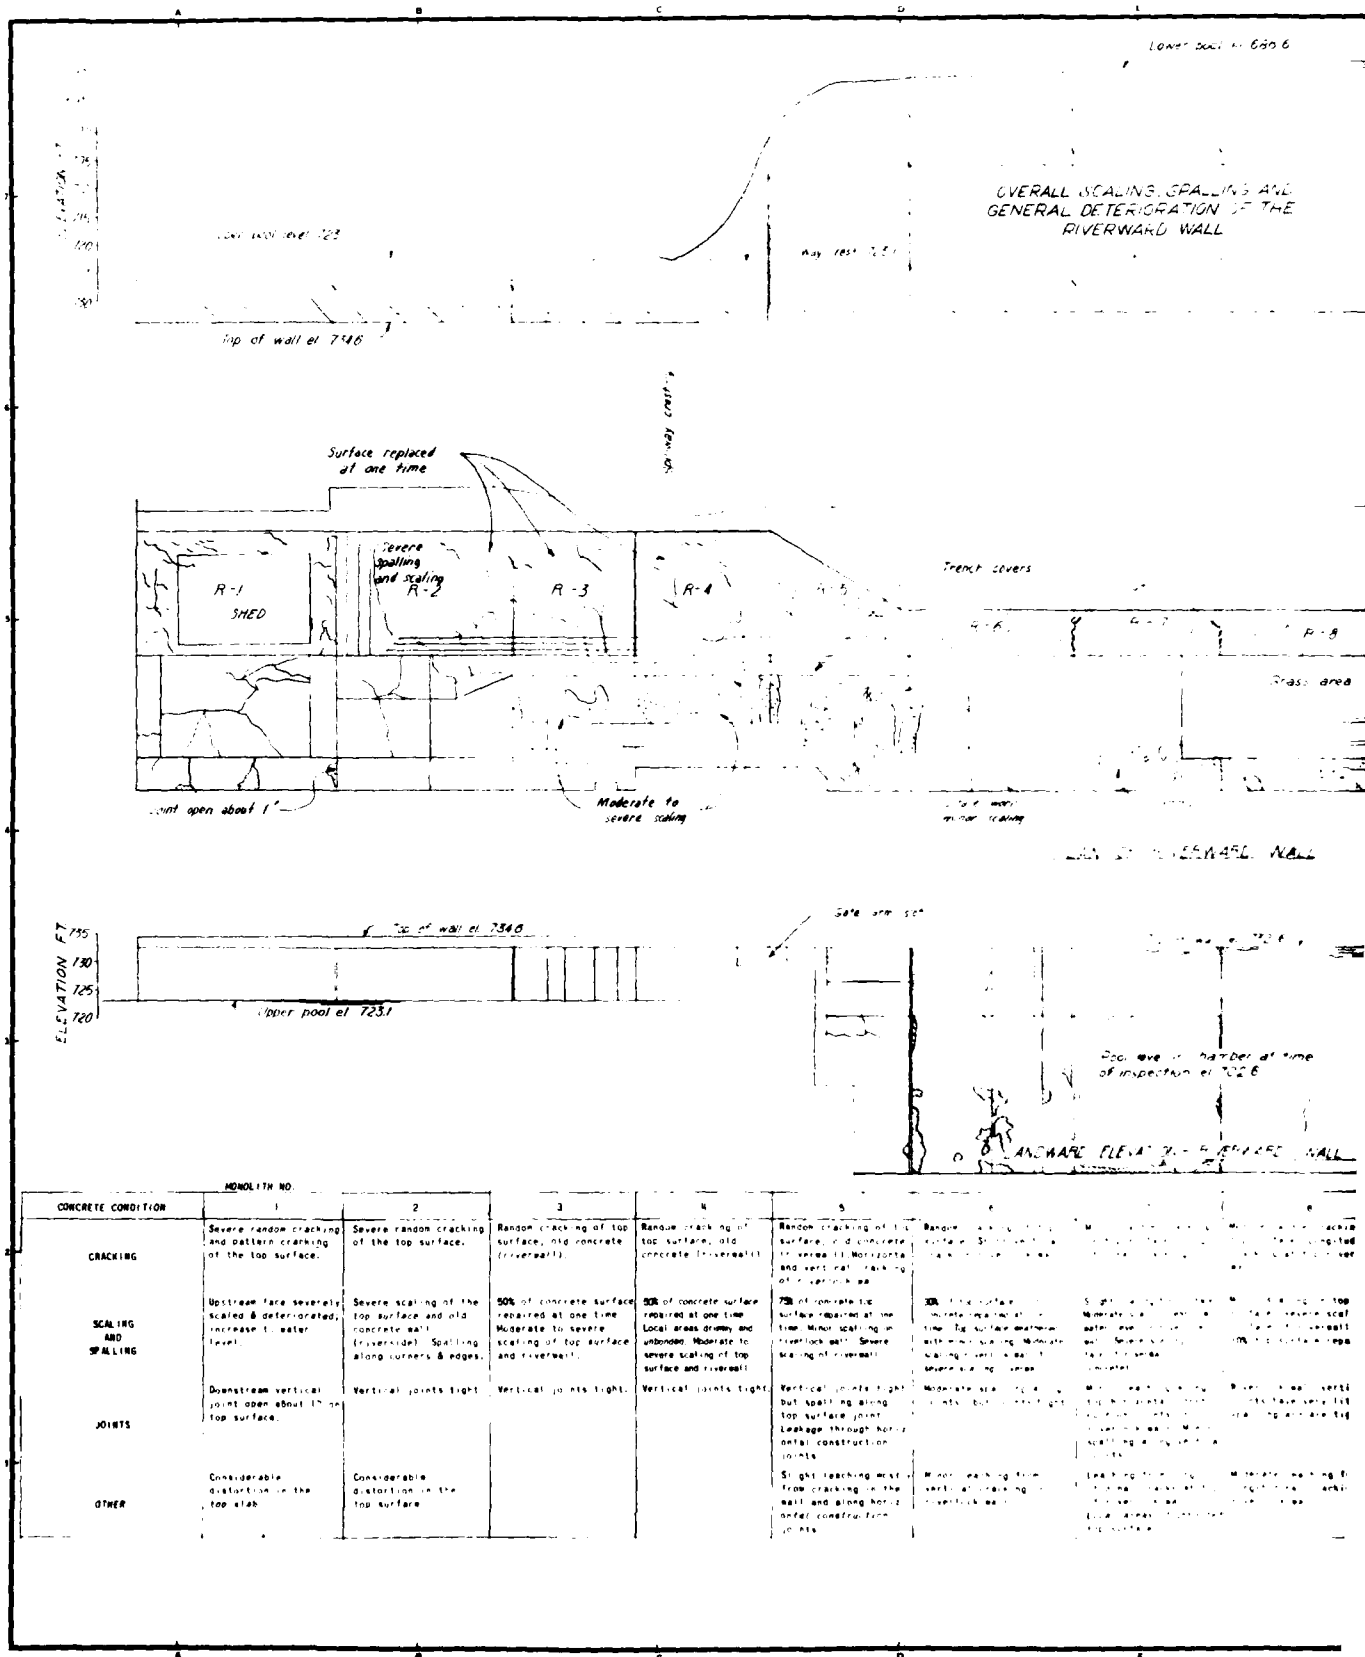
OVERALL SCALING, SPALLING AND
GENERAL DETERIORATION OF THE
RIVERWARD WALL

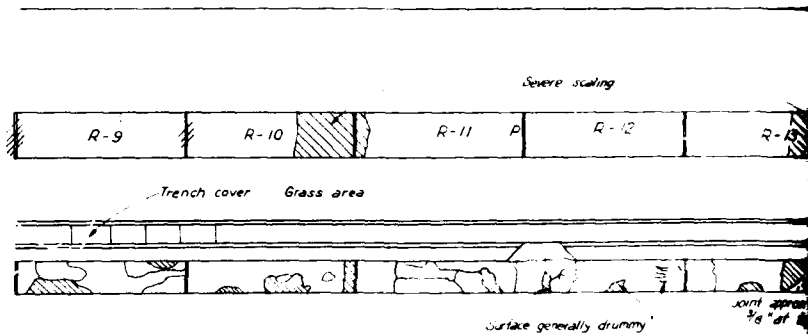
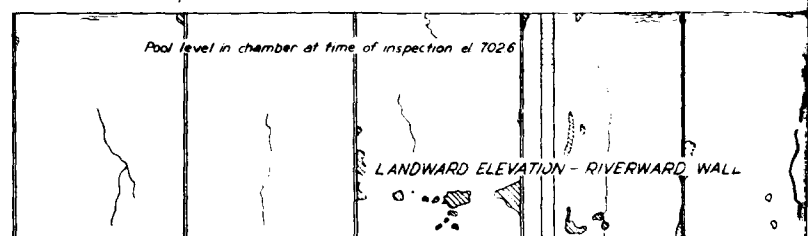
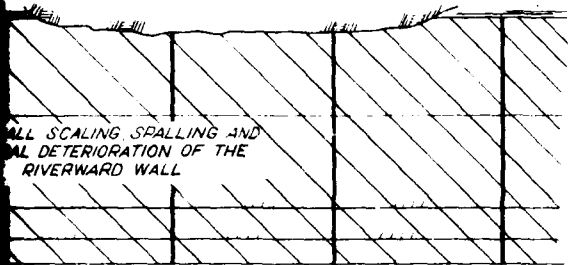
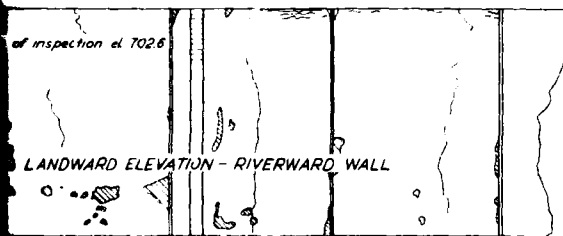
PLAN OF RIVERWARD WALL

Severe scaling

Surface generally drummy Joint approx 3/8" at top

11	12	13
Minor scaling at top of wall. Vertical cracks in upper half of wall.	Minor scaling at top of wall. Minor longitudinal cracking in upper half of wall. Vertical cracks in upper half of wall.	Minor longitudinal cracking at top of lower half of wall. Several vertical cracks in the upper half of wall.
Moderate scaling in the upper half of wall. Severe scaling in the lower half of wall. Moderate scaling in the lower half of wall.	Moderate scaling in the upper half of wall. Severe scaling in the lower half of wall. Moderate scaling in the lower half of wall.	Moderate to severe scaling of the top surface of the river wall. Minor to moderate scaling along vertical joints in river wall.
Vertical joint between R-11 and R-12 approx 3' 8" at the top. Also see scaling above.	Vertical joint between R-12 and R-13 approx 3' 8" at the top. Also see scaling above.	Vertical joint between R-13 and R-14 approx 3' 8" at the top. Also see scaling above.

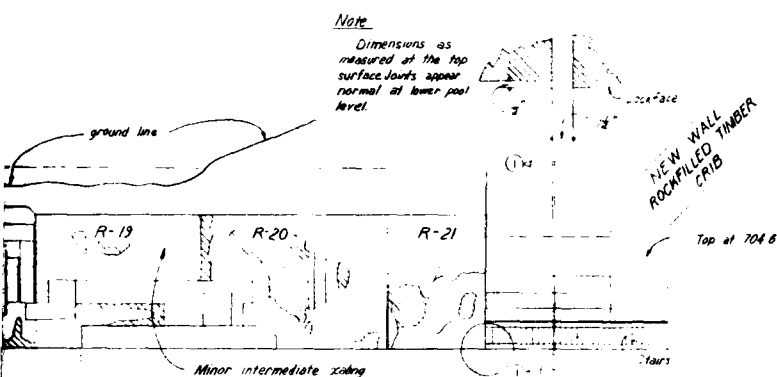
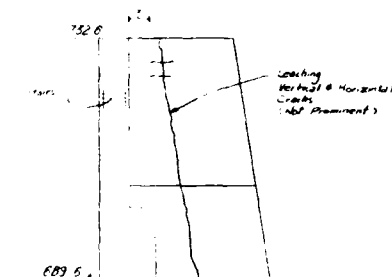
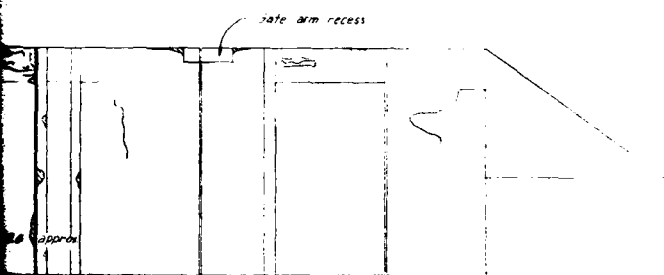
PLATE F-1

MONOLITH NO.		14	15	16	17	18	19	20
CONCRETE CONDITION								
CRACKING		Minor to moderate longitudinal cracking at top of riverlock wall. Vertical crack in riverlock wall. Minor random cracking in local areas of top surface.	Minor longitudinal cracking at top of riverlock wall. Vertical crack in riverlock wall.	Minor longitudinal cracking at top of riverlock wall. Several vertical cracks in riverlock wall.	Vertical and horizontal cracking in riverlock wall. Minor longitudinal cracks.	Severe longitudinal cracking at top of riverlock wall. Vertical crack in riverlock wall.	Some vertical cracks.	Minor longitudinal cracking at top of riverlock wall.
SCALING AND SPALLING		Severe scaling on river wall face and top of river wall. Minor scaling on top of riverlock wall.	Severe scaling on river wall face and top of river wall. Moderate weathering and scaling on top of riverlock wall.	Several scaling on river wall face and top of river wall. Minor surface scaling on top and face of riverlock wall.	Severe scaling on top of riverwall. Riverwall face weathered. Minor scaling and weathering on top, and moderate scaling & spalling on face of riverlock wall.	Moderate scaling of top surface. Minor spalling and scaling on riverlock wall.	Minor weathering on top surface, some scaling along edges of riverlock wall.	Minor spalling along vertical edges. Moderate scaling on top surface.

JOINTS		Vertical joints between mono #13 and mono #14. Open 3/8" at top.	Minor spalling along vertical joints in riverlock wall. Vertical joints tight.	Vertical joint between mono #16 and mono #17. Open 3/8" at top.	Vertical joint between mono #18 and mono #17. Open 3/8" at top.	Vertical joints tight.	Vertical joints tight. Leaching from horizontal construction joints on riverwall.	Vertical joints tight. Leaching from horizontal construction joints on riverwall.
OTHER		Moderate leaching from longitudinal cracks at top of riverlock wall.	Slight leaching from top of riverlock wall.	Minor leaching from longitudinal cracks at top of riverlock wall.	Minor to moderate leaching from longitudinal cracks and from vertical cracks in riverlock wall.	Severe leaching from longitudinal cracking to moderate along vertical cracks.	Minor leaching from vertical cracks.	Minor leaching from longitudinal cracks.

19	20	21	
Top wall.	Some vertical cracks.	Minor longitudinal cracking of top of riverlock wall.	Random cracking of top surface, vertical cracking in walls.	
on	Minor weathering with some scaling on top surface, some spalling along edges on riverlock wall.	Minor spalling along vertical edges. Moderate scaling on top surface.	Moderate scaling on top surface.	
to	Vertical joints tight. Leaching from horizontal construction joints on riverwall.	Vertical joints tight. Leaching from horizontal construction joints on riverwall.	Moderate scaling on top surface.	
to	Minor leaching from vertical cracks.	Minor leaching from longitudinal cracks.	Minor leaching from vertical cracks.	Construction joints generally rough.

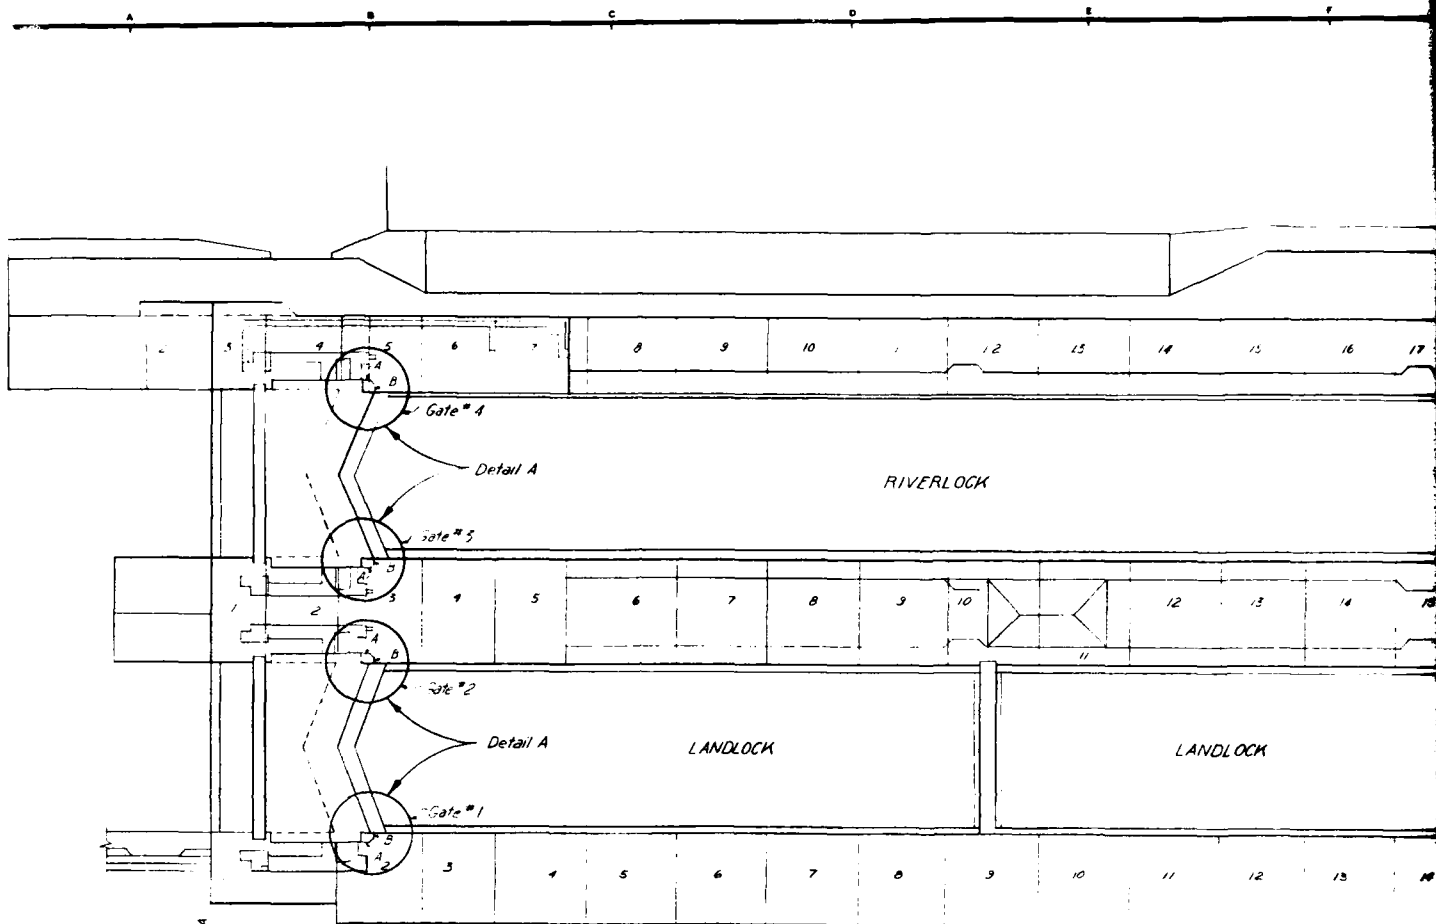
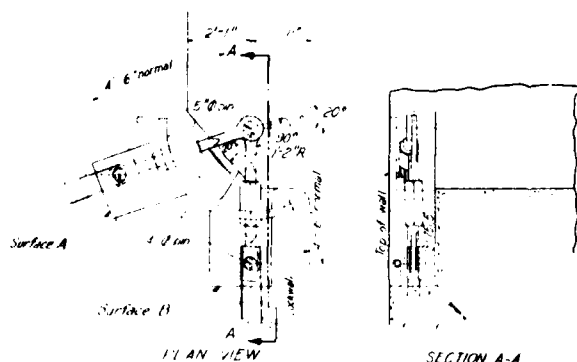
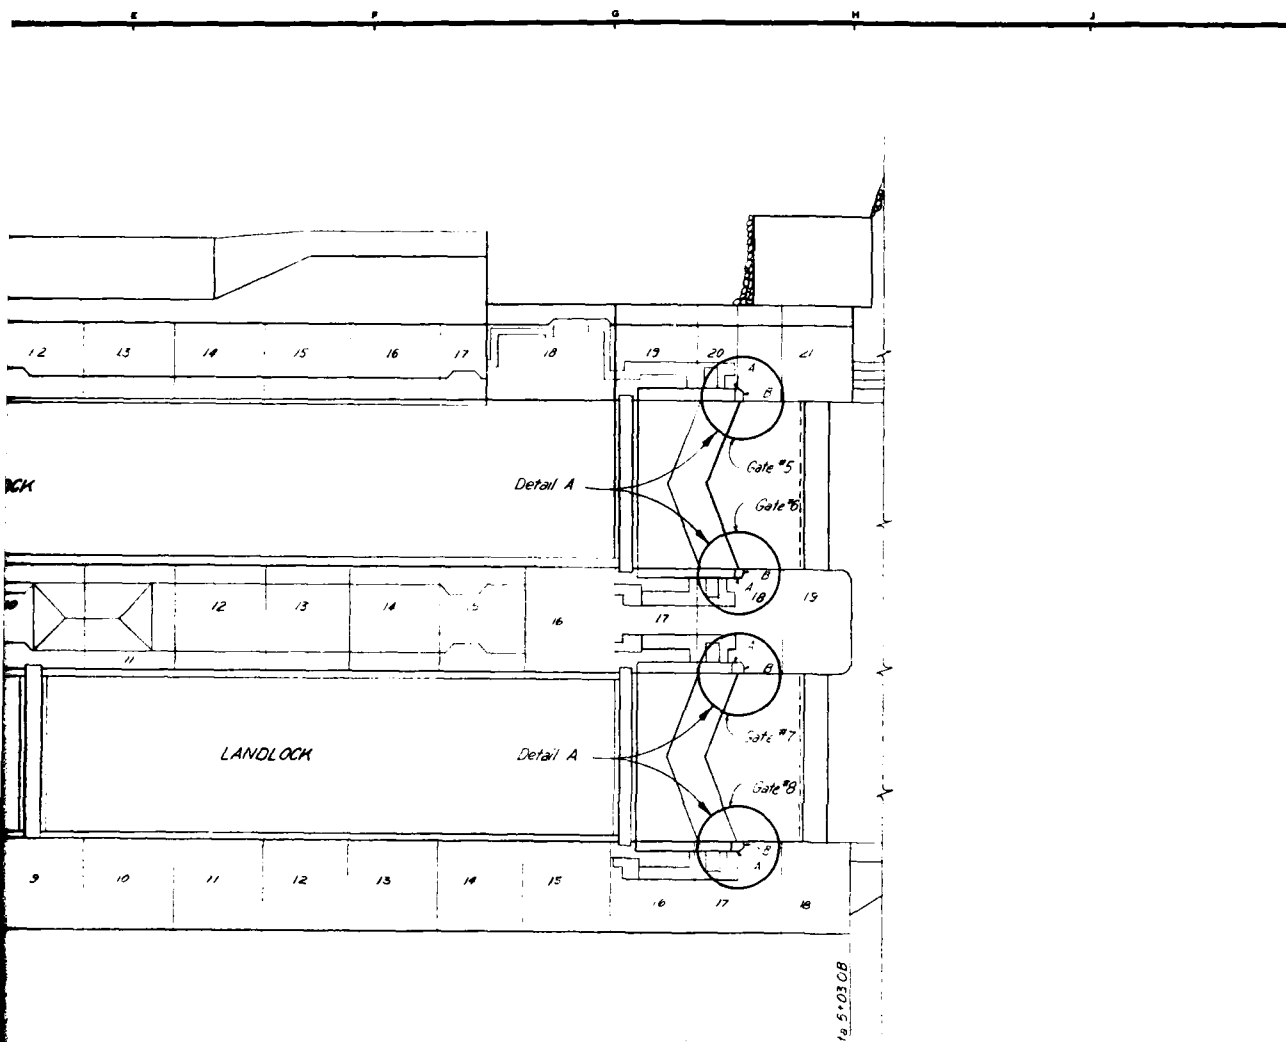
GATE ANCHORAGE
(A: shown for Landlock)
(B: shown for Riverlock)

- 1) The values of compressive strengths were obtained by Swiss Impact Hammer with an average value from 10 readings.
- 2) Surface scaling around anchor.
- 3) D-cracking and leaching.

SURFACE A"	SURFACE B"
4200 psi	3350 psi
3500 psi	6250 psi
4000 psi	4000 psi
3400 psi	4950 psi
3500 psi	2950 psi
4000 psi	3300 psi
5800 psi	6500 psi
6000 psi	5500 psi

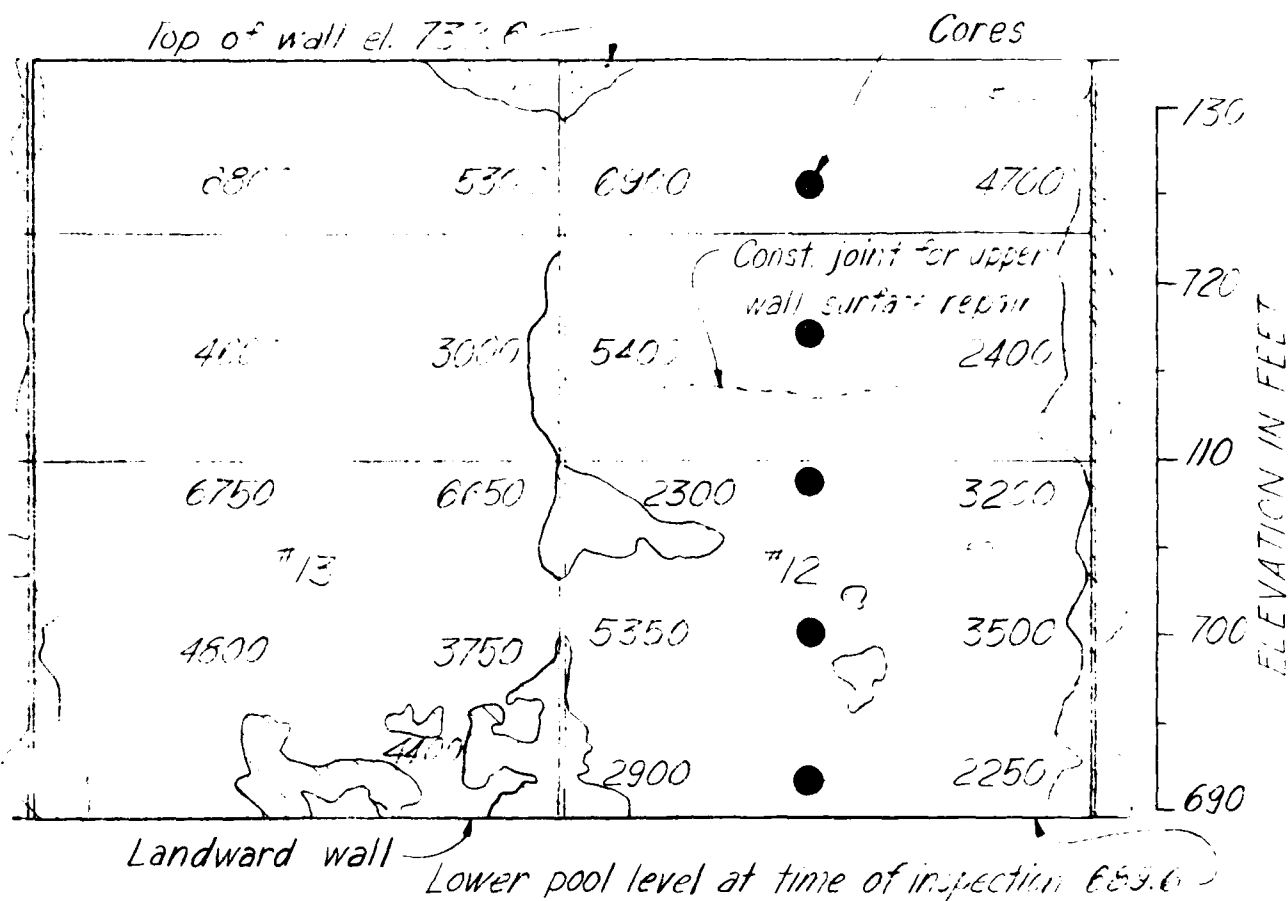
CONCRETE CONDITION SURVEY
SURFACE COMPRESSIVE STRENGTH

- 1.) Compressive strengths are in-place strengths at the location shown.
- 2.) All readings are in psi, taken from an average of 10 Swiss hammer readings.
- 3.) Horizontal cores are 11" deep
